# IN-PLANE TESTING OF DAMAGED MASONRY WALL REPAIRED WITH FRP

This paper describes the performance of a masonry wall repaired with glass fibre reinforced polymer, GFRP sheets. The original reinforced clay brick masonry wall was tested under in-plane lateral cyclic loading. Failure occurred due to yielding of the steel reinforcement and crushing of the bricks. After epoxy injection of the cracks and patching of the missing portions, the wall was repaired using GFRP sheets, applied in the horizontal and vertical directions, on one face of the wall, including the joint between the wall and concrete footing. The repaired wall was tested to failure in the same manner of the original wall. The results show that the strength and displacement capacities of the wall were completely restored and even exceeded the original capacities.

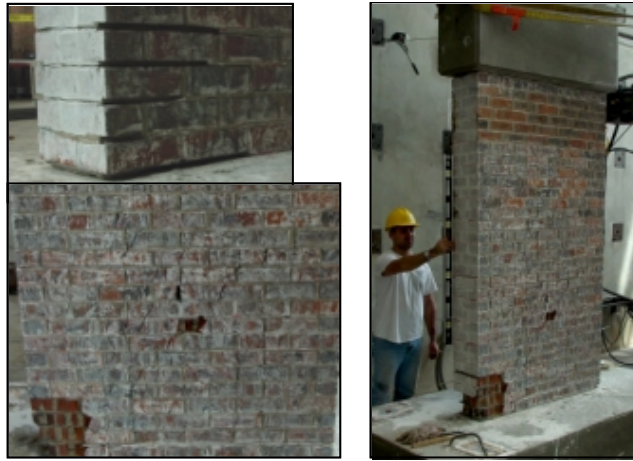
Fig. 4: Failure of the wall after first testing (cracking and crushing of bricks and mortar joints)

completed. The maximum force obtained was 324 kN. Flexural and shear cracks up to 1.27 mm and 1.52 mm respectively were observed and the second course of masonry on one end of the wall was crushed as shown in Fig. 4. On the other end of the wall, the bottom layer of mortar was crushed and spalled up to a depth of 390 mm. The mortar joints within a height of 280 mm also spalled over a depth of 290 mm. Due to the excessive damage and softening, which affected the stability of the wall, loading was terminated after the first cycle of displacement ductility 4.

All loose particles were removed using a hand grinder, wire brush, a hammer, chisel and a vacuum. The wall was readjusted to vertical position using straps and wire pulleys. The missing parts of the bricks in the compression zone as well as the mortar joints were patched with new cement mortar after being wetted and allowed to dry. All cracks were patched using a Quickseal Type Epoxy. During patching, injection ports were placed at different points over the surface on one side of the wall in order to inject epoxy grout into the wall. The epoxy grout had tensile strength and modulus of 51 MPa and 2.23 GPa respectively. As the epoxy grout leaked from ports on the opposite side of the wall and above, the hoses were moved up the wall and leaking ports were capped. Quick-setting hydro cement, dried with a heat gun, was used to stop

leaks from the surface. Later, the hydro cement and epoxy patches were removed from the surface using hammers. A grinder was then used to expose the brick faces, mortar joints and the upper face of the concrete footing to achieve good bond. Grinding revealed that cracks were closed tightly by the epoxy grout.

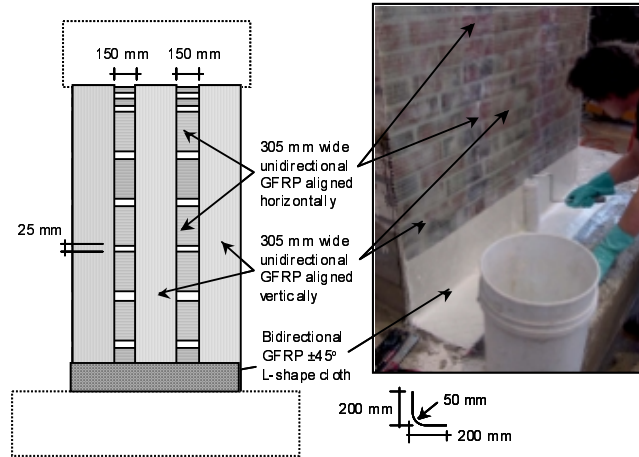
**Fig. 5:** Repair scheme of the damaged wall using GFRP

The GFRP repair scheme incorporated unidirectional E glass woven fabric, placed only on one face of the wall in the horizontal and vertical directions as well as a bi-directional fabric with fibres oriented at  $\pm 45$  degrees placed at the joint between the wall and footing as shown in Fig.5. Epoxy primer coat was applied to the wall, footing, and the unidirectional GFRP fabrics. The epoxy resin had tensile strength and modulus of 72 MPa and 3.18 GPa respectively. The horizontal unidirectional sheets were placed first with gaps of about 25 mm in between. Precautions were taken to ensure that the gaps spanned over the brick face and not at the joints. The vertical GFRP sheets were then placed over the horizontal sheets. A 50 mm radius was built up along the bottom of the wall using a mixture of epoxy and silica fume paste in order to eliminate sharp corner at the interface of the footing and wall. The L-shape bi-directional fabric was then laid up dry at the corner and saturated with epoxy resin as shown in Fig. 5. The GFRP repair system was left to cure for two weeks.

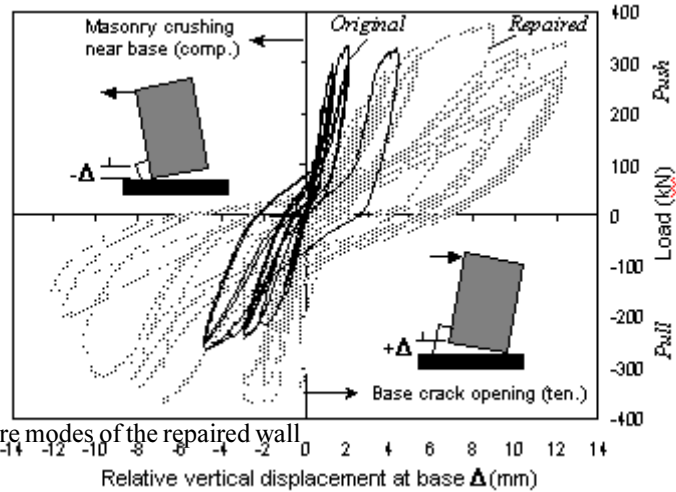
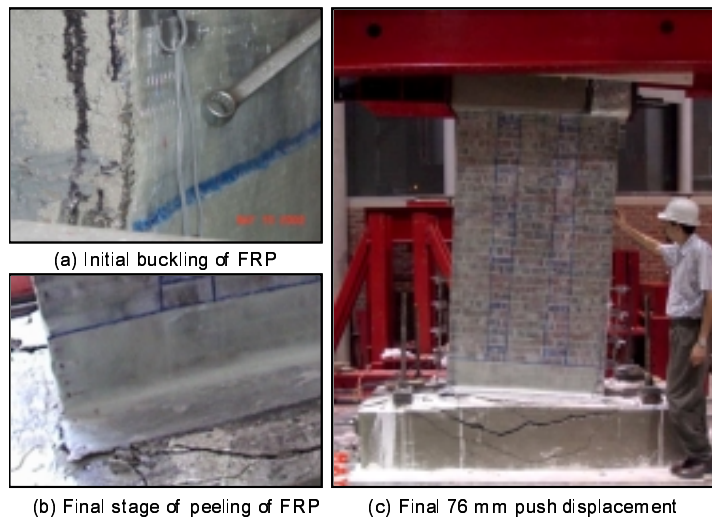
At early stages of load control, the base crack began to open. Fig. 6 shows the variation of relative vertical displacement between the wall and the base with the load for the original and repaired wall tests. The figure shows that the base crack opening is wider in the repaired specimen at any given load. This could be attributed to the softening of the interface after the first testing as well as to the fact that the presence of vertical GFRP sheets added stiffness to the wall and shifted the point of rotation towards the interface with the base. The upward force on the tension side produced peeling stresses on the horizontal side

of the L-shape bi-directional fabric, resulting in opening of the base crack. As the wall is pulled back the crack closes and eventually the compressive stresses produces crushing of the mortar joints and bricks at the interface with the base as indicated by the negative vertical displacement in Fig. 6. During the  $\pm 23$  mm cycles, vertical splitting of the masonry as well as delamination and outward local buckling of the vertical GFRP sheets occurred at the edge of the wall on one end, just above the L-shape GFRP bi-directional layer, as shown in Fig. 7(a). Through the  $\pm 30$  mm cycles, buckling of GFRP and cracking of masonry progressed. During the  $\pm 46$  mm cycles, buckling of GFRP and crushing of masonry increased on the other end. Through the  $\pm 61$  mm cycles, degradation of the wall continued where the repair mortar cracked and spalled. Also cracking of the footing became visible. The successive opening and closing of the interface crack between the wall and footing throughout the increasing loading cycles allowed the peeling process to propagate within large area of the horizontal side of the L-shape bi-directional fabric, causing separation from the concrete base as shown in Fig. 7(b). The final  $+ 76$  mm push displacement of the wall is shown in Fig. 7(c), which also shows excessive damage occurring in the concrete footing. Close inspection of the wall during and after the test revealed that a new pattern of cracks developed and that the old cracks did not open. It should also be noted that the capacity of the repaired wall was limited by the capacity of the

Fig. 7 Failure modes of the repaired wall

Fig. 7 : Failure modes of the repaired wall

concrete footing and even better behaviour would have been possible if the footing did not fail.
