REPAIR OF PRESTRESSED CONCRETE BRIDGE GIRDERS WITH FRP

Keywords: Prestressed, repair, fiber reinforced polymers, impact-damaged, flexure, shear, bridge girder.

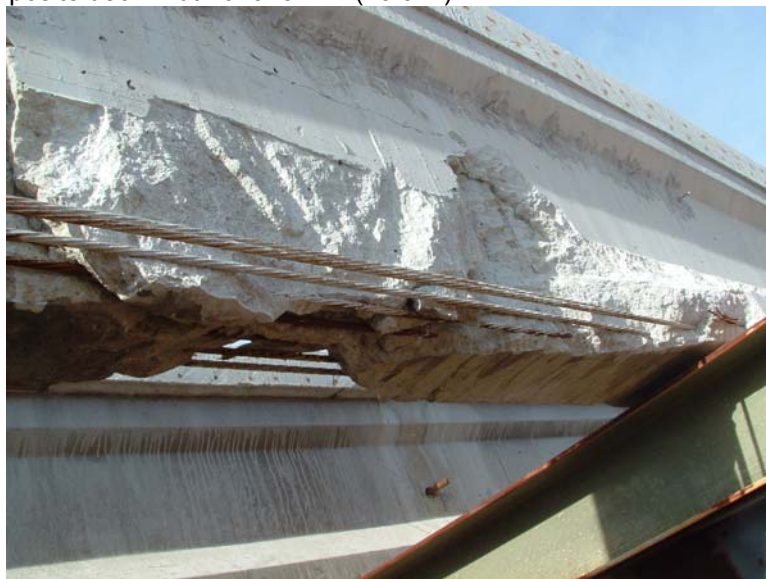
Fig. 1 AASHTO1 at NCDOT yard after impact damage.

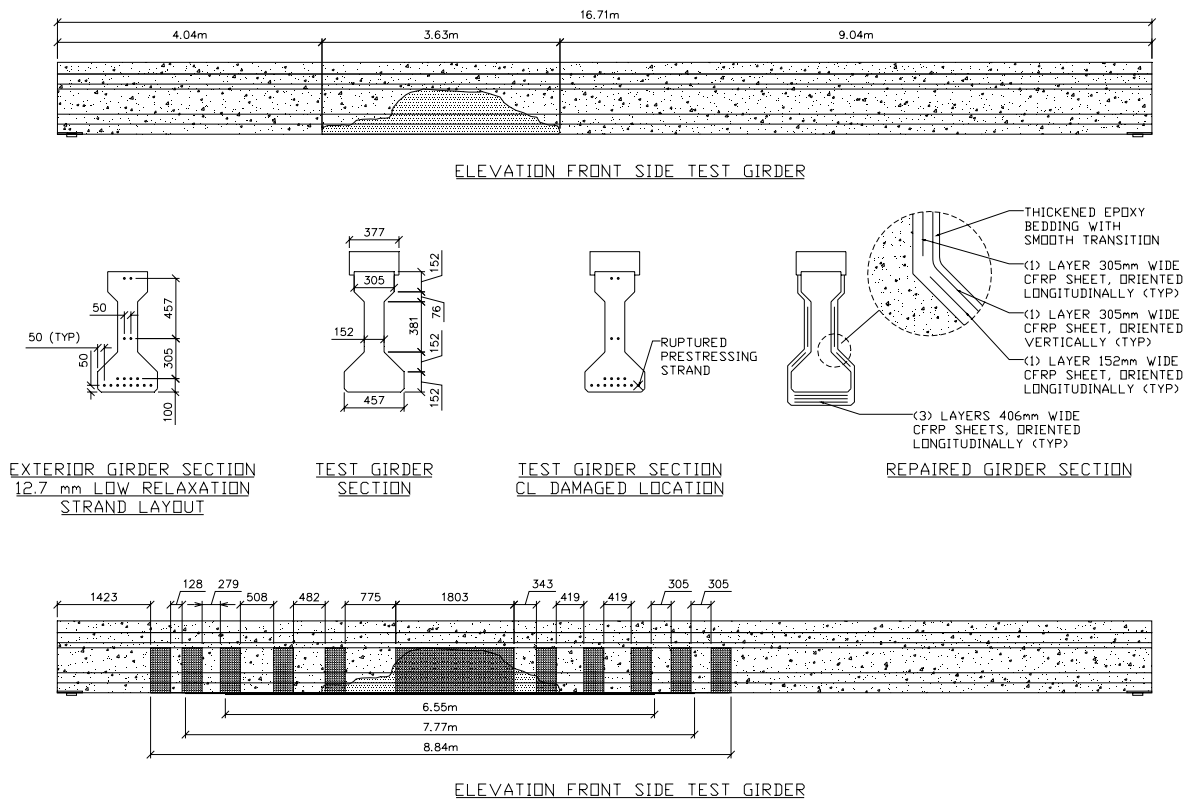
AASHTO1 was the first girder tested in this research project. The test girder was an AASHTO Type II girder prestressed with sixteen 12.7 mm (0.5 in) – 7 wire 1860 MPa (270 ksi) straight prestressing strands. The total length of the tested girder was 16.71 m (54.84 ft) with a center-to-center support span of 16.26 m (53.34 ft). The girder, after impact damage from an overheight vehicle, is shown in Figure 1. The approximate volume of damaged concrete was equal to 0.1 m³ (4.8 ft³). In addition to the loss of concrete, one prestressing strand on the bottom layer was ruptured on the front side, resulting in a 6.3 percent loss of prestressing force. The full 2.13 m (7.0 ft) composite bridge deck was not part of the test specimen since it was cut through in order to remove the damaged girder from the bridge superstructure. The average width of the composite deck of the test girder was 388 mm (14.9 in). Cross section and elevation drawings of AASHTO1 are shown in Figure 2.

Fig. 2 AASHTO1 girder cross section, elevation, and CFRP design details.

section. To ensure proper utilization of the CFRP's strength and strain capacity, the damaged concrete section was restored using a two part repair mortar as well as adequate development length of the longitudinal sheets was provided. The final design of the CFRP repair system for AASHTO1 is shown in Figure 2, while girders AASHTO2 and AASHTO3 are shown in Figure 3.

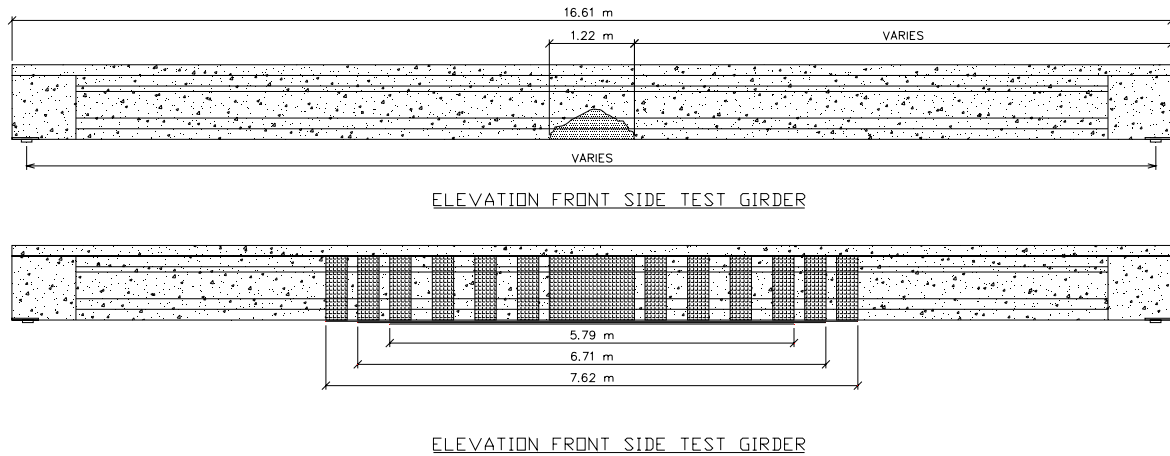
Fig. 3 AASHTO2 and AASHTO3 girders' damaged and repaired elevations.

Both AASHTO2 and AASHTO3 were received by the researchers undamaged. In order to simulate impact damage exhibited by AASHTO1, a large portion of the tension flange of the girders was removed, with four and three prestressing strands being removed from AASHTO2 and AASHTO3, respectively. The damage caused a 14.3 and 18.8 percent reduction in prestressing force, respectively. Approximately 0.06 m³ (2.2 ft³) of concrete was removed from both girders. The damaged and repaired elevations of AASHTO2 and AASHTO3 are shown in Figure 3.

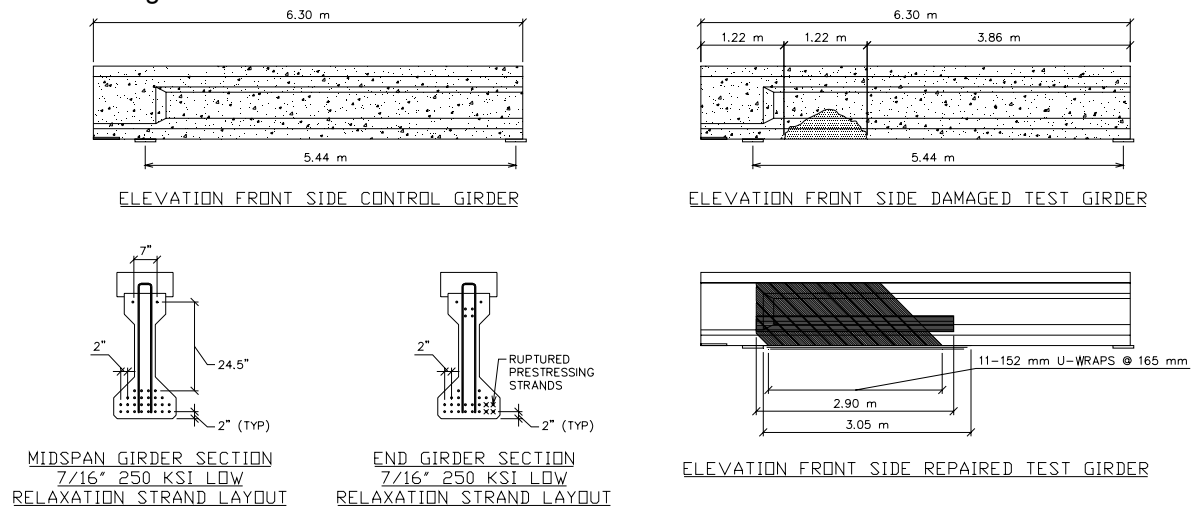
In order to simulate impact damage in AASHTO2R, a large portion of the tension flange of the girder, including a small section of the web, was removed, and four prestressing strands were ruptured corresponding to a reduction in prestressing force of 14.3 percent. A total of approximately 0.04 m³ (1.5 ft³) of concrete was removed. Figure 4 shows the elevation of both the AASHTO2C and AASHTO2R girders.

Fig. 4 AASHTO2C and AASHTO2R elevations.

The design of the CFRP repair system for AASHTO2R consisted of two phases; the flexural repair and the shear repair. The flexural analysis and repair was performed in the same manner described above. The shear repair was performed using the current Precast/Prestressed Concrete Institute (PCI) Handbook [9] to determine the shear capacity along the entire length of the member for the undamaged and then damaged section. After the damaged concrete section was restored with repair mortar, the required width and spacing of transverse diagonal CFRP sheets was determined using ACI Committee 440 [10] guidelines.

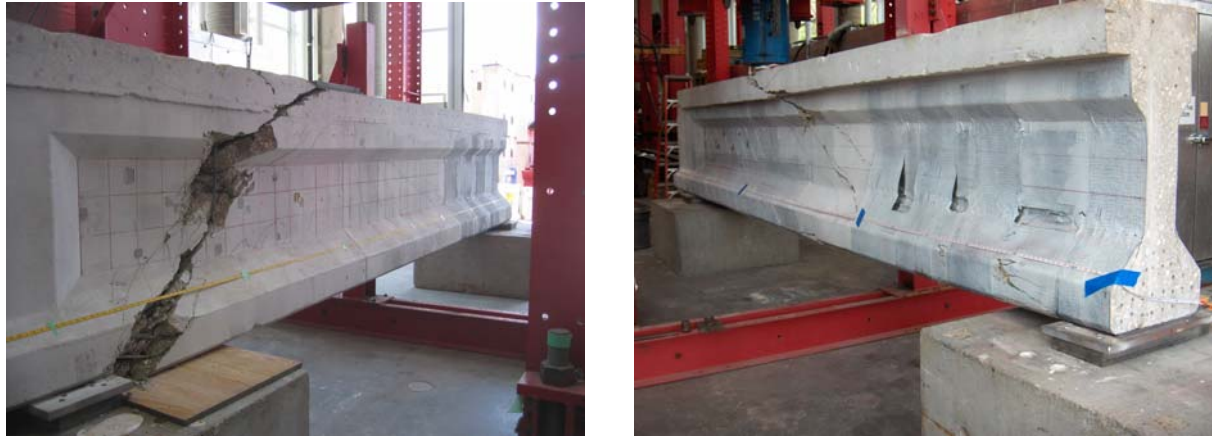
The ultimate failure of AASHTO2C initiated in the inclined cracks that formed on the shear-critical side of the test specimen from the support to the loading plate. The failure of AASHTO2R initiated

beyond the longitudinal CFRP sheets after shear failure in the right transfer region had occurred. The diagonal CFRP struts located in the shear-critical region of the member remained intact after the failure of AASHTO2R. The ultimate load capacity of AASHTO2R was 7 percent higher than that of AASHTO2C, and the ultimate displacement was slightly enhanced. Figure 6 shows the failure of girders AASHTO2C and AASHTO2R.

Fig. 6 Ultimate failure of girders AASHTO2C (left) and AASHTO2R (right)
