STATIC AND FATIGUE PERFORMANCE OF 40 YEAR OLD PRESTRESSED CONCRETE GIRDERS STRENGTHENED WITH VARIOUS CFRP SYSTEMS

O. A. ROSENBOOM, Dr. T. K. HASSAN

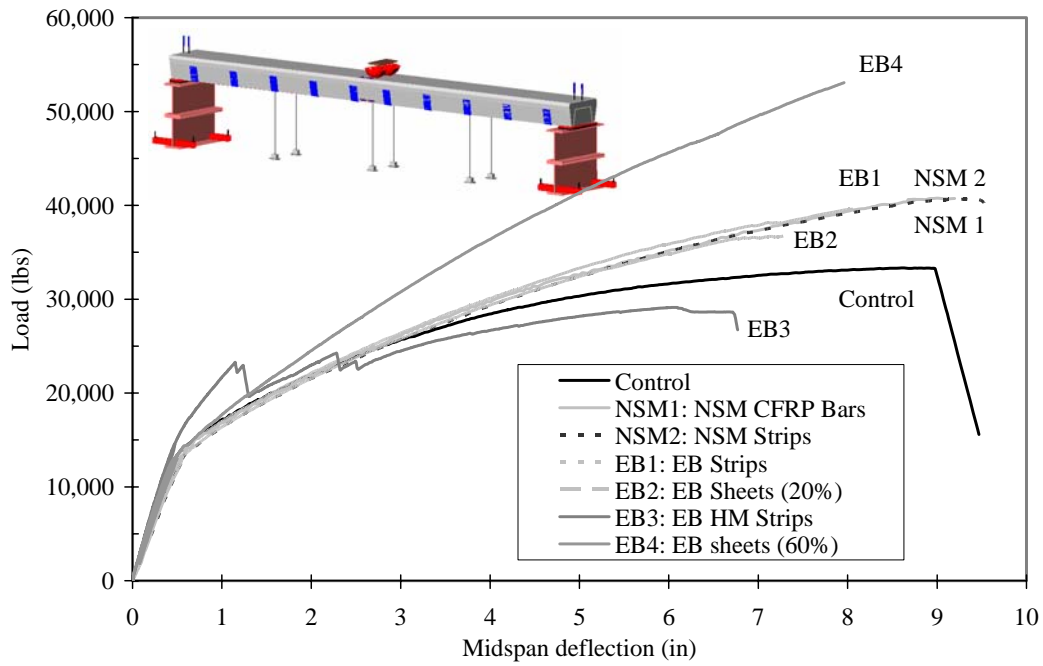
Figure 3. Load-deflection behavior of static test specimens

All the tested girders were uncracked prior to testing. Cracking of the control girder (S0) occurred at a load of 12.6 kips (55.8 kN). Flexural cracks were evenly distributed along the length of the girder, approximately at the location of mild steel stirrups. Yielding of the bottom prestressing strands took place at a load level of 25.8 kips (115 kN) measured by the PI gauge readings. Failure was due to crushing of concrete at a load level of 33.2 kips (148 kN) which corresponded to a deflection of 9in (228 mm). The average crack width at failure, calculated from PI gauge readings at the tension face, was 0.08 in (1.9 mm). Due to the confining effect induced by the loading tires, crushing of the concrete occurred first at the edge of the girder at midspan before it occurred underneath the loading area. The maximum measured concrete compressive strain at failure was 0.0029. The load-deflection behavior is shown in Figure 3. This plot does not include the measured camber for each girder. The load-crack width behavior of all statically tested girders is shown in Fig. 4.

The two girders, S1 and S2, strengthened with a NSM system using either FRP bars or strips respectively, performed similarly during testing. Flexural cracking was observed at a load level of 12.4 kips (55 kN) for both girders. The initial stiffness of both girders was similar to that of the control girder, as was the post-cracking stiffness. After yielding of the prestressing strands, the presence of the CFRP reinforcement constrained opening of the cracks and consequently reduced the midspan deflection compared to the control girder. The mild steel stirrups again acted as crack initiators, but other cracks between the stirrups were also observed. The failure of both girders strengthened with NSM CFRP reinforcement was due to concrete crushing followed by debonding of the NSM CFRP reinforcement at a load of 40.8 kips (181 kN) for the NSM bars and 40.7 kips (180 kN) for the NSM strips as shown in Fig. 5. Since the ultimate strain in the concrete controlled the failure mode of both girders, the curvature and consequently, the deflection at ultimate were very similar. Test results showed that strengthening of the prestressed girders using NSM CFRP bars and strips increased the ultimate load carrying capacity of the girder by 22.9 and 22.6 percent with respect to the control girder.

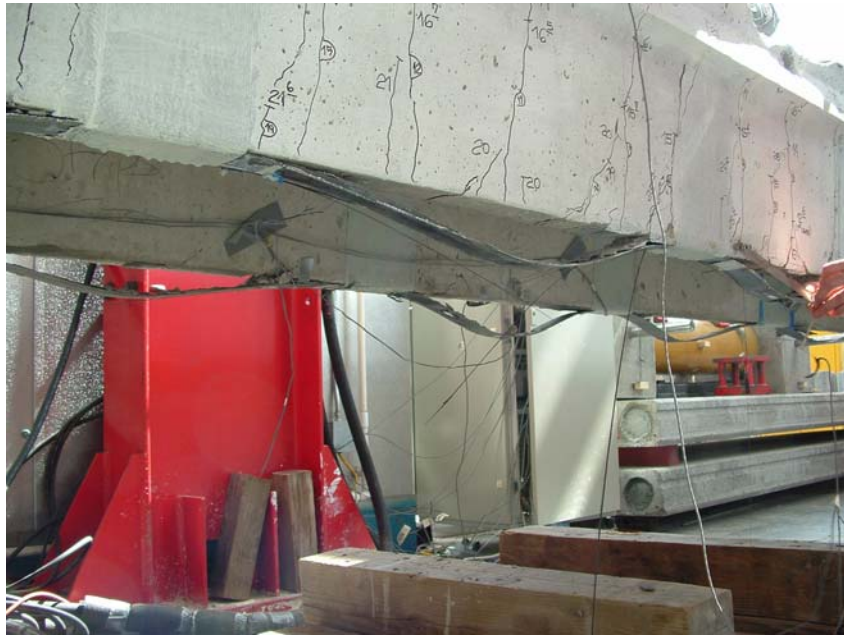
Figure 6. Debonding failure of externally bonded strips in girder S3

A total of four girders were strengthened with externally bonded CFRP systems. The behavior of the prestressed concrete girder strengthened with externally bonded CFRP strips (S3) and the girder strengthened with 2.5 plies of externally bonded sheets (S4) matched those of the NSM strengthened girders before and after cracking as shown in Figure 3. Flexural cracking at midspan was observed at a load level of 11.9 kips (57 kN) for both specimens. The cracking pattern and average crack width at midspan was similar to that of the NSM-strengthened girders. For girder S3, failure occurred due to debonding of the strips at midspan at a load level of 39.6 kips (176 kN) as shown in Fig. 6. The majority of the debonding occurred within the concrete substrate, although in several places debonding was noticed within the CFRP strip (interlaminar debonding). Compared to the control girder, S3 achieved an increase in the ultimate load carrying capacity of 19 percent.
