# IN-PLANE TESTING OF DAMAGED MASONRY WALL REPAIRED WITH FRP

This paper describes the performance of a masonry wall repaired with glass fibre reinforced polymer, GFRP sheets. The original reinforced clay brick masonry wall was tested under in-plane lateral cyclic loading. Failure occurred due to yielding of the steel reinforcement and crushing of the bricks. After epoxy injection of the cracks and patching of the missing portions, the wall was repaired using GFRP sheets, applied in the horizontal and vertical directions, on one face of the wall, including the joint between the wall and concrete footing. The repaired wall was tested to failure in the same manner of the original wall. The results show that the strength and displacement capacities of the wall were completely restored and even exceeded the original capacities.

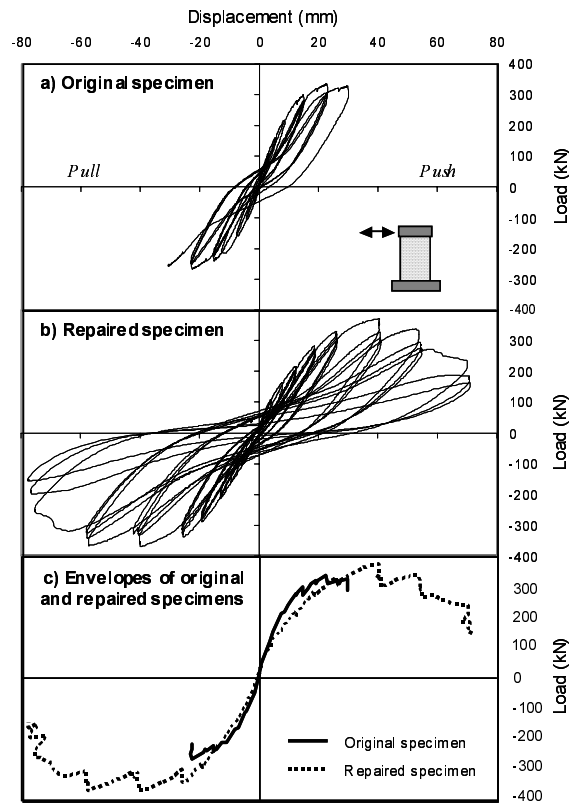
**Fig. 3 :** Load-displacement responses of the wall before and after repair

The load-lateral displacement response of the first testing of the masonry wall is shown in Fig. 3(a) [6]. On the first cycle, a  $\pm 53$  kN load was applied and the wall deflected 1 mm. Few flexural cracks opened

The repaired specimen was retested using the same test setup and loading history adopted for the original wall, shown in Fig. 2. Fig. 3(b) shows the load-displacement response of the repaired wall. The load-displacement envelopes of the original and repaired specimens are compared in Fig. 3(c). The repaired wall exhibited an initial stiffness lower than the original wall, however, the maximum load capacities of the repaired wall were 11 and 38 percent in the push and pull directions respectively. The repaired wall was able to endure three full cycles of  $\pm 76$  mm displacement-based loading (displacement ductility 5) as shown in Fig. 3(b), and was subsequently pushed to a maximum displacement of 203 mm before substantial damage of the concrete footing ended the test.
