REPAIR OF PRESTRESSED CONCRETE BRIDGE GIRDERS WITH FRP

Keywords: Prestressed, repair, fiber reinforced polymers, impact-damaged, flexure, shear, bridge girder.

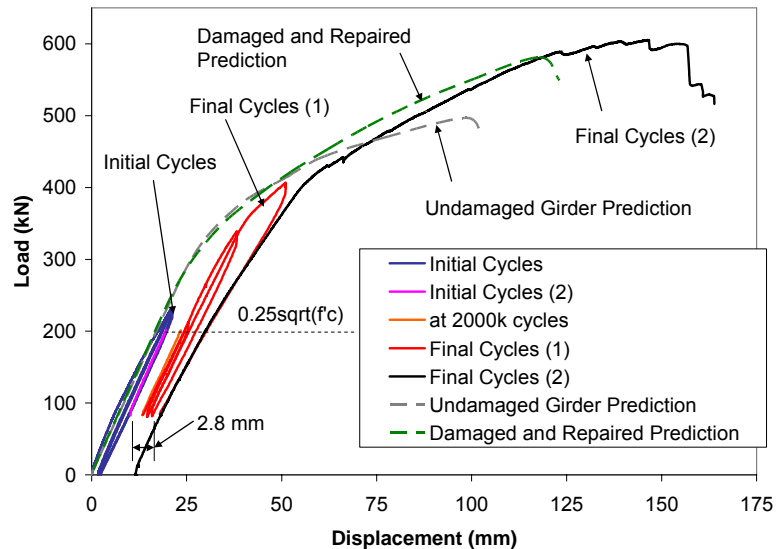
The applied load versus midspan displacement relationship for the fatigue loading between 83.2 kN to 201.1 kN (18.7 k to 45.2 k) for the repaired AASHTO1 girder is shown in Figure 5. The girder survived 2 million cycles with very little degradation or crack propagation in the repaired region after the initial cycles. Fatigue creep of concrete [12] caused small amounts of displacement degradation totaling 2.8 mm (0.11 in) after 2 million cycles of loading. No stiffness degradation in the girder was observed after completion of the fatigue loading regime.

The overall behavior of the repaired girder far exceeded the predicted strength of the undamaged girder in both strength and ultimate displacement, as shown in Figure 5. The predicted response of the undamaged girder is also shown in Figure 5. Concrete crushing was the predicted failure of the

damaged and repaired girder at an applied load of 645 kN (145.1 k), which corresponds well to the measured load at failure of 605 kN (136.1 k). The measured ultimate load was 17.6 percent higher than the ultimate load predicted for the undamaged girder, which could be caused by the slight over-designed CFRP repair system. The measured ultimate displacement of the repaired girder was 37 percent greater than the undamaged prediction and 5.2 percent greater than the repaired prediction.

Fig. 5 Load vs displacement for AASHTO1

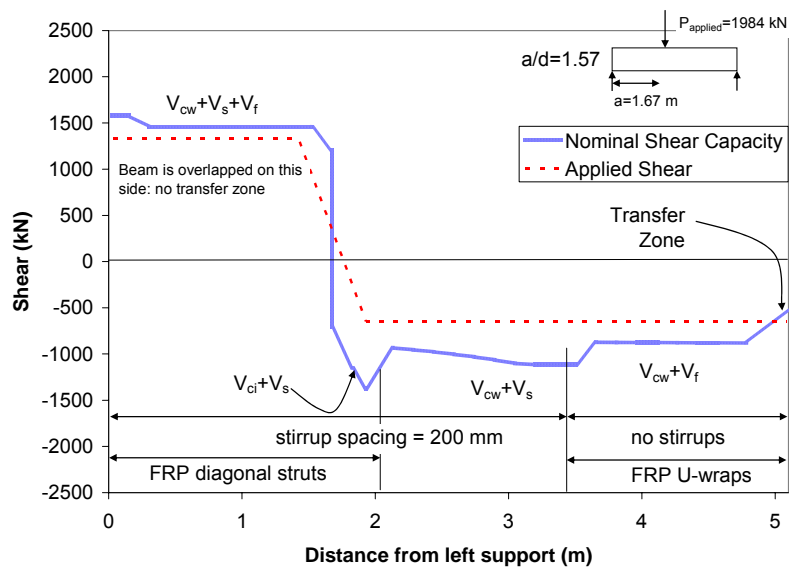
Fig. 7 Predicted shear capacity versus the applied shear load of girder AASHTO2R

The predicted shear capacity versus the applied shear demand for AASHTO2R is shown in Figure 7. The initial predicted shear failure load was 2309 kN (519 k), but the test specimen failed at 1985 kN (446 k). The initial prediction would have been accurate if shear failure to the left of the applied load, the shear-critical span, had occurred, however this was not the failure mode observed. From Figure 7, it is evident that the applied shear at the right end exceeded the allowable shear in the transfer region. Shear failure in the transfer region allowed the prestressing strands to debond, in turn lowering the moment capacity of the section on the right end. The moment capacity of the girder became much less after the contribution of the prestressing strands is progressively lowered due to debonding, leading to a flexure-shear failure in combination with plate end debonding at the termination point of the longitudinal CFRP sheets.
