Preliminary summary of damage surveys from the November 15, 2008 tornado outbreak.

...Tornado survey of Sampson County including the Clement Community EF-0 Tornado...

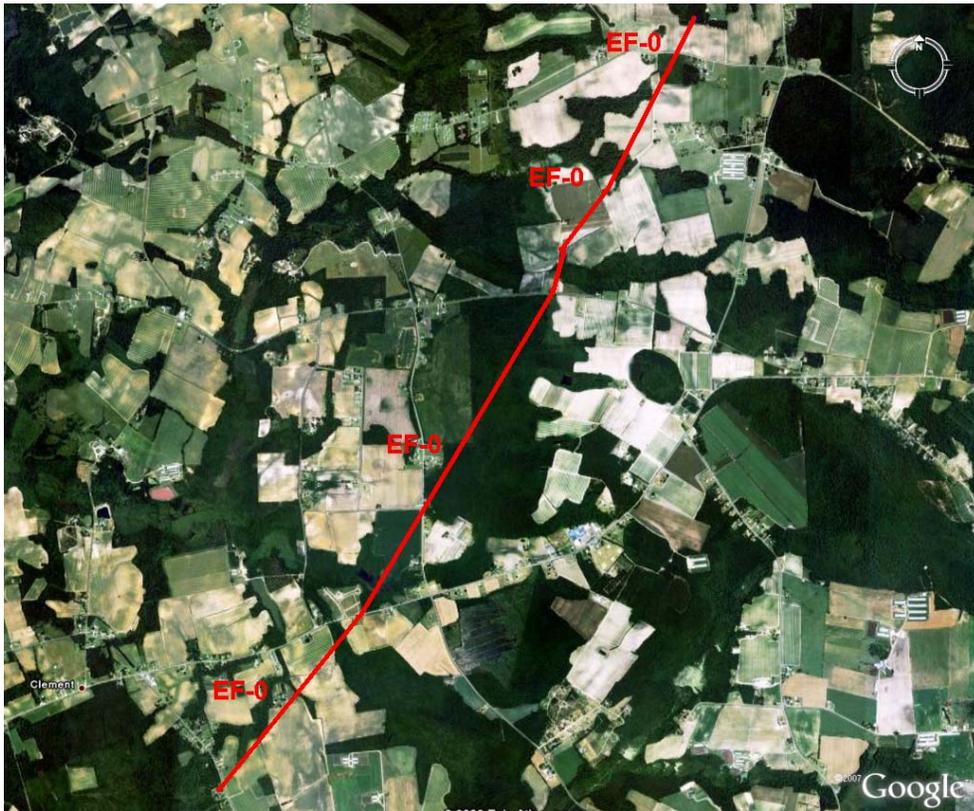
Tornado track of the Clement EF-0 tornado

The National Weather Service, in conjunction with Sampson County Emergency management, determined that an EF-0 tornado touched down in western Sampson County near the Clement community. The tornado damage track was discontinuous along an approximately four-mile path that extended from Carroll Store Road just south of Maxwell Road, across Maxwell Road, through several properties between Hayes Mill Road and Baptist Chapel road east of the community of Hays Mill, to just north of Baptist Chapel Road west of state road 1452.

The most significant damage was concentrated at a dwelling along Maxwell road, where trees were snapped, a carport was blown and twisted into trees, and shrubs were pulled from the ground. Much of the damage was consistent with straight-line wind damage, however, the degree of damage at the dwelling on Maxwell Road, the number of snapped trees aloft, and sporadic indication of tree damage perpendicular to the track of the tornado would indicate the likelihood of a tornado. Fortunately, there were no injuries reported. Estimated width of the tornado was 50 yards.

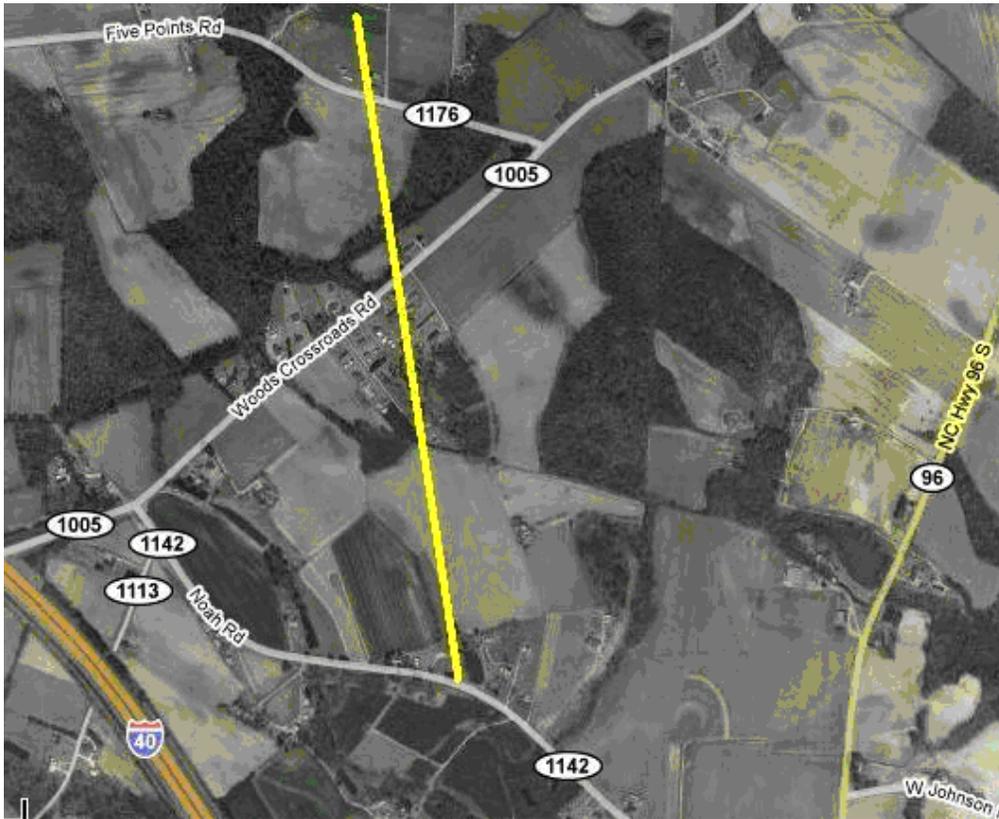
Tornado track of the Meadows EF-1 tornado

The National Weather Service found that an EF-1 tornado touched down in southwestern Johnston County just south of Blackman Crossroads at 248 AM EST. The tornado damage track was approximately 50 feet wide and extended north-northwest for approximately one mile.

The tornado initially touched down just off Noah Road, where there were several uprooted trees. It traveled north-northwest across bare fields with scattered mature trees for about one half mile and crossed Wood Crossroads, producing significant roof damage to one double-wide mobile home and tearing the porch off a substantial brick single-level home. An occupant of the mobile home confirmed that the damage occurred at 248 AM. There were several mature trees that had been twisted off at mid and upper reaches as well.

The tornado then continued north-northwest across open fields before producing minor damage on Five Points Road to the aluminum skirt of a double-wide mobile home and other minor damage to sheds and storage buildings. There was also some tree damage in this area which knocked down power lines.

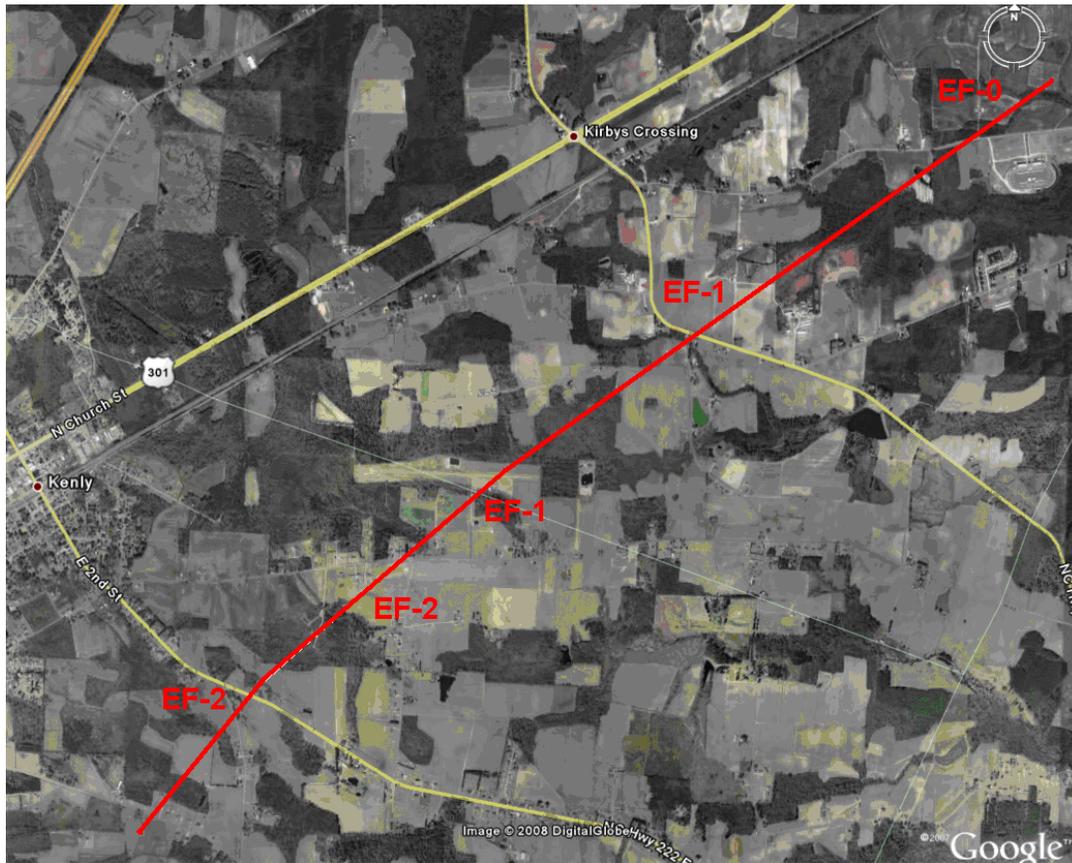
Tornado track of the Kenly – Lucama EF-2 tornado

The National Weather Service, in conjunction with Johnston county emergency management, determined that an EF-2 tornado touched down in northern Johnston County just southeast of the town of Kenly. The tornado damage track was about 150 feet wide and stretched for approximately 4.5 miles into southwest Wilson County. The tornado initially touched down around 310 AM just north of Piney Grove Church Road, and damage was limited to minor tree and structural damage. The tornado then tracked northeast, over bare fields and stands of mature trees for about three quarters of a mile, twisting off mature trees, before producing significant damage at the intersection of NC highway 222 and Crumpler Road.

Continuing northeast, the tornado moved across the Kenly International Airport. The tornado was likely aloft at this point, producing EF-1 damage to trees, but there was considerable debris from the homes on Scott Road strewn about the airport grounds. A portion of an open aircraft hangar constructed of sheet tin over a wooden frame was twisted and destroyed. There was also some damage to the Cessna 150 housed in this hangar.

The tornado then crossed into southwest Wilson county causing damage to several mobile homes along Fabwhitley Road. Several other homes in the Lucama area suffered minor damage from the strong winds. The tornado finally lifted off the ground just north of Newsom Mill Road near a local racetrack.

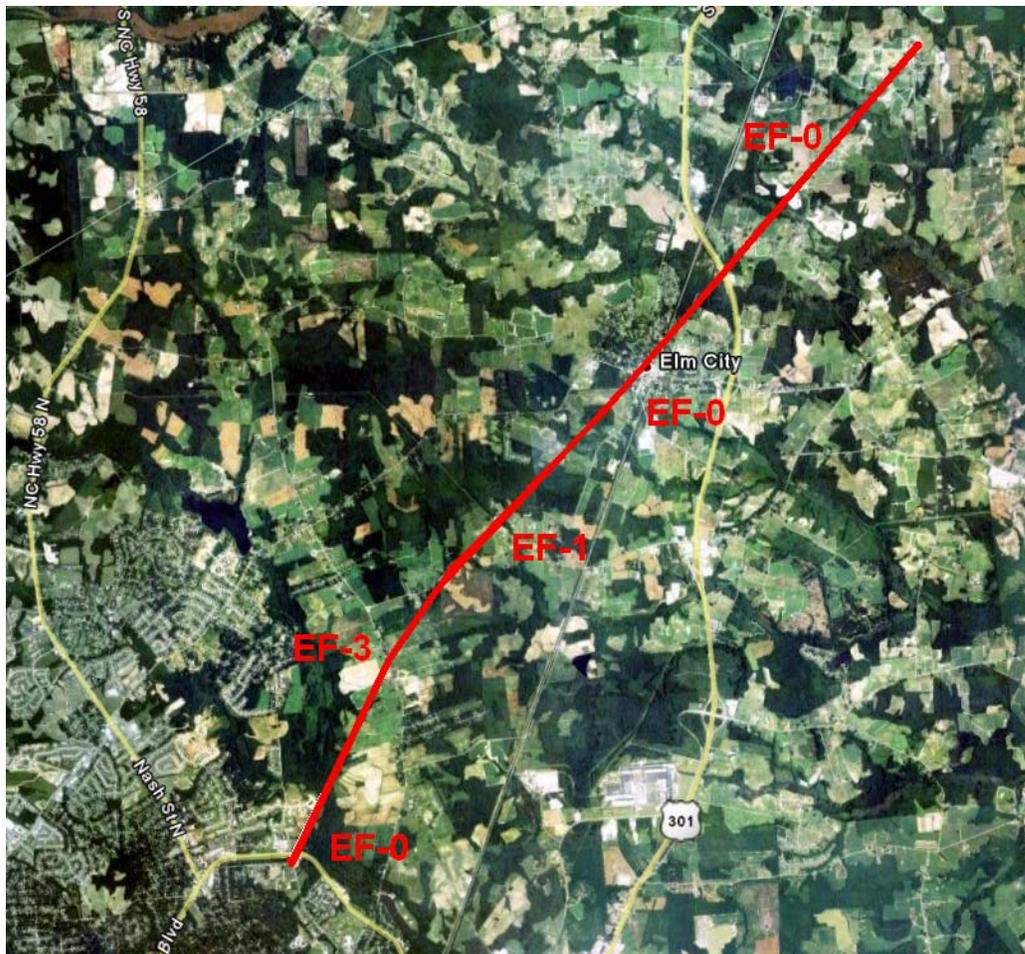
Tornado track of the Wilson – Elm City EF-3 tornado

The National Weather Service, in conjunction with Wilson County emergency services and Wilson Fire and Rescue, determined that an EF-3 tornado occurred in Wilson County. The tornado occurred along a discontinuous, approximately eight-mile path that began with minor roof damage to a dwelling and a snapped tree along Harrison drive just south of Ward Boulevard. The most significant damage was then noted to the northeast, along London Church Road, south of Route 1330.
